California Water Research Technical Memo

July 2018

Dr. Clyde Thomas Williams

Under-Seepage and Seismic Safety Issues at Clifton Court Forebay

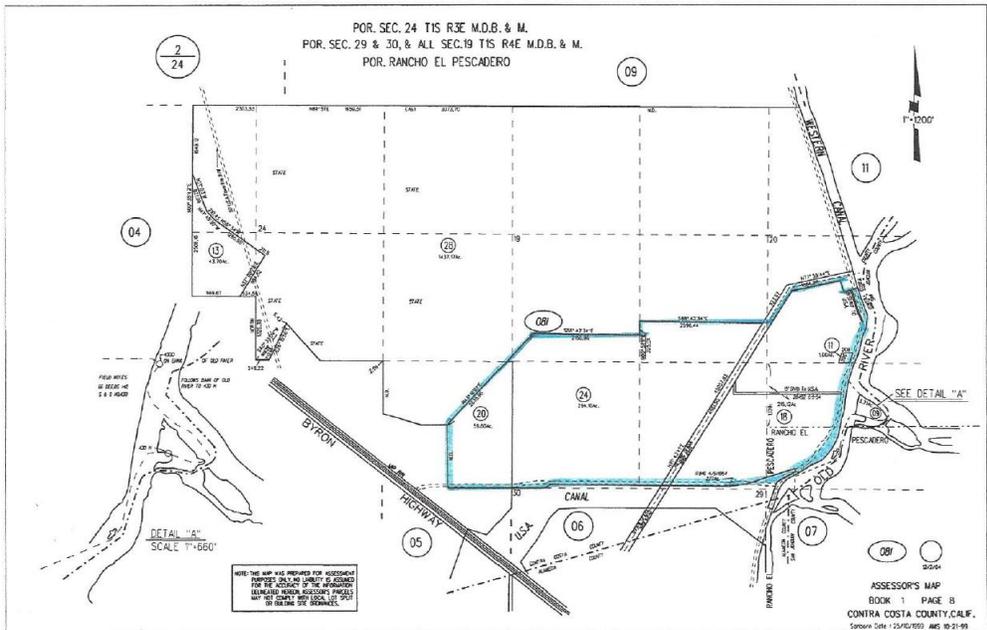
Suzanne Womack, a partner in Clifton Court LLP, has reported ongoing seepage on land next to Clifton Court Forebay to the State Water Resources Control Board in the WaterFix Change Petition Hearing. Ms. Womack testified in the Hearing that seepage started after the Forebay was constructed, and has continued. She stated that seepage severely impaired 25 acres during the drought, and impaired another 15 acres. The area of impairment reportedly expanded in 2017. Ms. Womack states that after talking to her tenant farmer, she believes seepage may be affecting up to 70 acres. Ms. Womack called the Delta Field Division of the Department of Water Resources in 2017 to report the seepage. As described below, the resulting investigation appears to have been cursory and inadequate, given that under-seepage is a failure mode for the Forebay embankment.

1 Assessor's Map showing Clifton Court LLP property Source: Exhibit CCLP-11
